1 Purpose of Document

This document summarizes the changes between the previous AS14U silicon revision C and the current silicon revision E. These include requested UART design changes. The purpose of the redesign was to correct reported timing errors by the UART in the following modes: Master, Monitor, and Repeater. A problem with slave communication in special network constellations was also fixed.

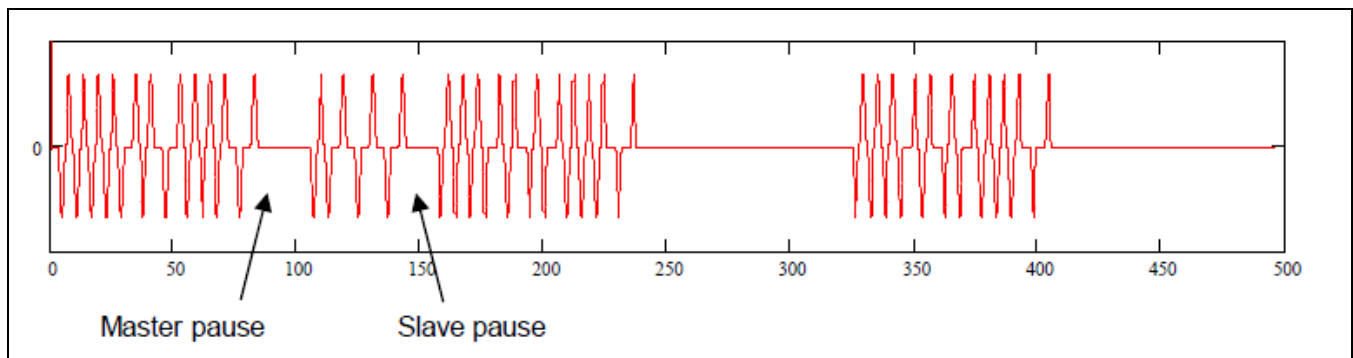
Figure 3.1 Test for ASI4U Revision C Error in Master Pause Detection

If the previous ASI4U revision C is operated in Slave Mode, the UART Master Pause detection does not always function correctly when the UART must listen to slave responses from a different slave. Depending on the actual AS-I line pulse timing, a slave response from a different slave is sometimes not recognized correctly, which results in a UART communication error. This prevents the Slave from understanding the next Master telegram correctly. If the Master telegram addresses the Slave itself, the error leads to a missing slave response and the Slave replies on a second repetition of the Master Call to its own address in asynchronous mode.

This behavior was mostly observed in mixed networks that used modules with the ASI4U, SAP5, and SAP4.1.

Figure 3.1 shows a telegram test case to reproduce the error. The AS-I signals shown in Figure 3.1 were generated by a signal generator that allowed sweeping the Master Pause and Slave Pause duration over the allowed specification limit. The first Master Call contains a different slave address than the tested slave. The second and third master calls address the tested slave. The tested slave replied with the erroneous behavior for certain Master pause and Slave pause scenarios only. The majority of the test cases were passed without error.

A new principle of AS-i telegram pause detection was implemented in ASI4U silicon revision E that is more precise and able to cover all valid timing scenarios for Master and Slave pauses. The new principle is now independent of the internal timing constraints of the UART state machine.
